# Water Body Detection and Monitoring Due to Urbanization

Zurairhan Mohamad, Na'im Farhana Abdul Rahim, Masayu Norman,  
Ashnita Rahim & Fazly Amri Mohd

Center of Studies for Surveying Science and Geomatics,  
Faculty of Architecture, Planning & Surveying,  
Universiti Teknologi MARA, 02600 Arau, Perlis

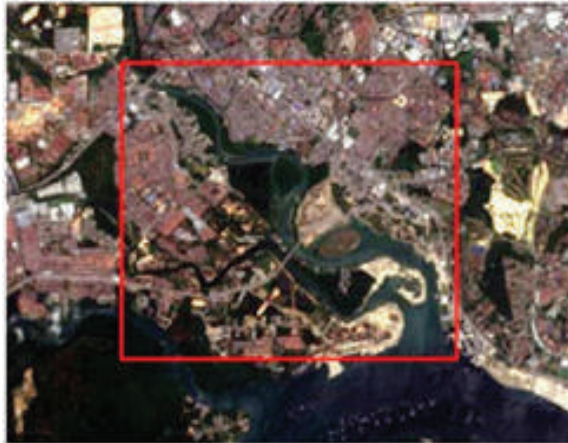
**Figure 1:** Study area in Pulai, Johor Source: Google Earth (2019)

Located along Tebrau Strait, Pulai was chosen to be study area for this project. With coordinates of 1.4970°N, 103.6131°E, Pulai is located at south west area of Johor state. This project focused on the area along Johor River in the region of Pulai (area within red box). The area covered is 1063.53 hectares and the length of the river in the Pulai region is 7089.12m. Connected to Tebrau Strait, the river in the study area is the main feature to be analyzed in this project. The area covered by the river will be compare in 2013 and 2019 due to urbanization growth in Pulai region.

Historically, the location of Johor state along Tebrau Strait has become its key factor for the state's increasing rate of population growth. The increase of population leads to urbanization in the regions of the state, including Pulai. A significant growth of urbanization in certain area can be shown by obviously increasing area of township, populated areas (residential), industrial area, roads and highways and other facilities. In this project, the areas covered by the river and urbanization studied to proven the change of the river affected by the urban growth in Pulai region (Figure 1).

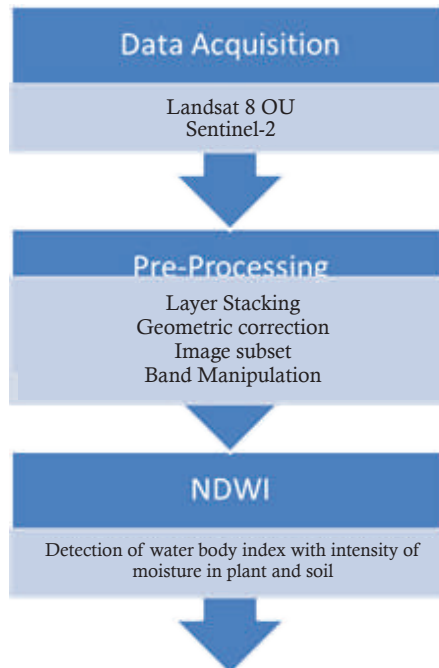
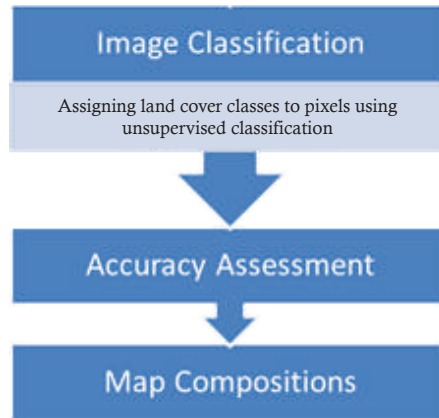
**Figure 2:** Flow of Study

Image classification technique is done to group pixels to represent land cover features, exist on the image. Unsupervised image classification is one of the common classification technique often used in digital image processing. Unsupervised classification on is a form of pixel based classification and it is essentially computer automated classification. User only specifies the number of classes and the spectral classes are created solely based on the numerical information in the data. The pixels are grouped together based on their spectral similarity. Figure 2 shows the flow of the data processing.

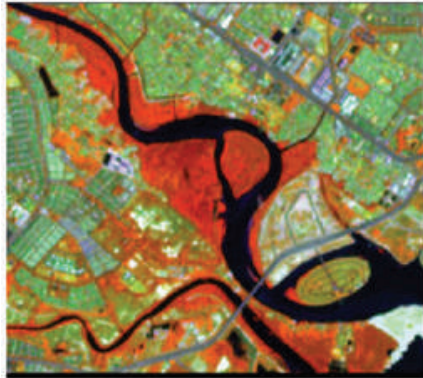
**Figure 3:** Band Manipulation for Detecting Water Areas

From the output of multispectral bands combination from both Landsat 8 imagery and Sentinel-2 imagery in the next pages, the presence of water body can be identified by the dark blue-colored feature on the map. The non-water body features with water body feature distinguished clearly with multispectral band combination. Even though both imageries have different range of spectral bands, but both the output for both Landsat 8 and Sentinel-2 multispectral bands combination for land/water analysis are almost same to each other.

As for detecting presence of water feature, multispectral bands combination and NDWI techniques were used in this project. Based on the outputs for both techniques, it seems that application of remote sensing in detecting water body is really useful and reliable. Based on the image interpretation in Figure 3, water body of Johor River can be clearly identified in the image. The dark blue colour represents water feature while orange colour represent vegetation and green colour represent land cover. The objective of detecting presence of water body in the imagery is achieved successfully using multispectral bands combination technique. In this technique, actually there are other bands combinations that can be used to define and interpret the imagery based on the study topic and it is differs for different datasets.

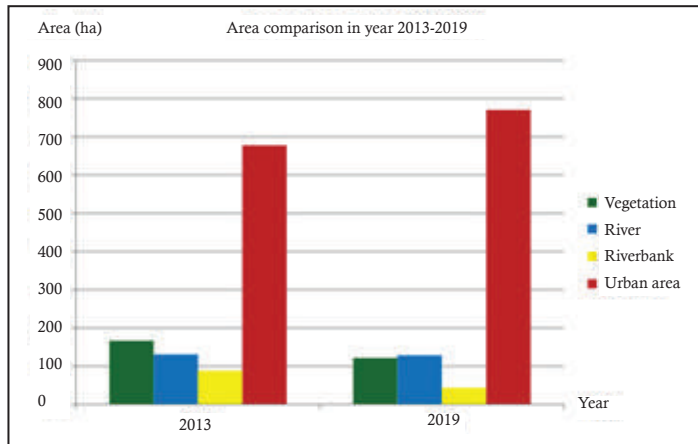
As for monitoring the changes of Johor River and the effect of urbanization towards the size of the river, it can be shown in Table 2 and Figure 5. The difference in seven years is clearly shown in both tables, interpreted with digital analysis of remote sensing. It can be seen that the total area of this project is 1063.53 hectares with some features classed as river, riverbank, vegetation and manmade features mapped. In seven (7) years, it is clear that the embankment of the river is decreased by 44.93 hectares and the river also reduced by 2.67 hectares. The vegetation area, including plantation and forestation also decrease by 4.16 percent. Meanwhile, urbanization (manmade features) keep grading by 92.66 hectares until 2019.
